CWMYDWRGI TYDDYNOD

Roof Survey

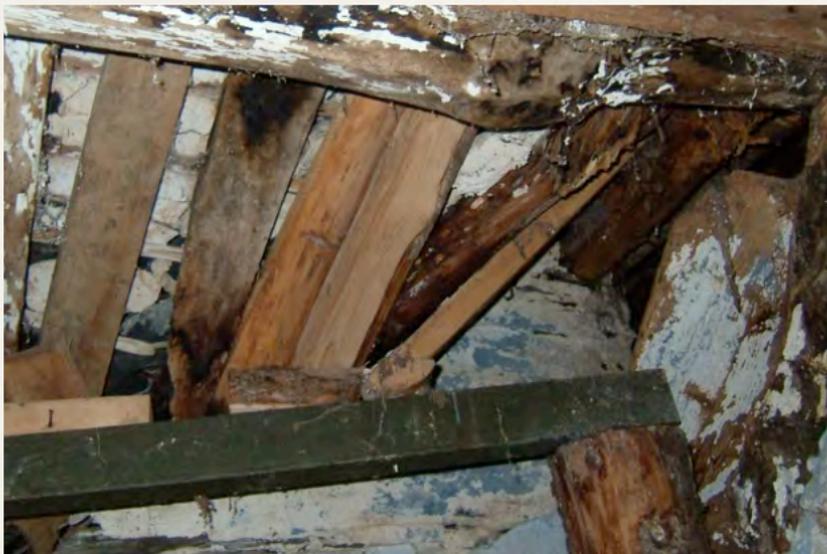
The roof timbers are extensively rotted and collapsed which has allowed the slating to sag opening the joints in it.
Much of the torching has fallen away

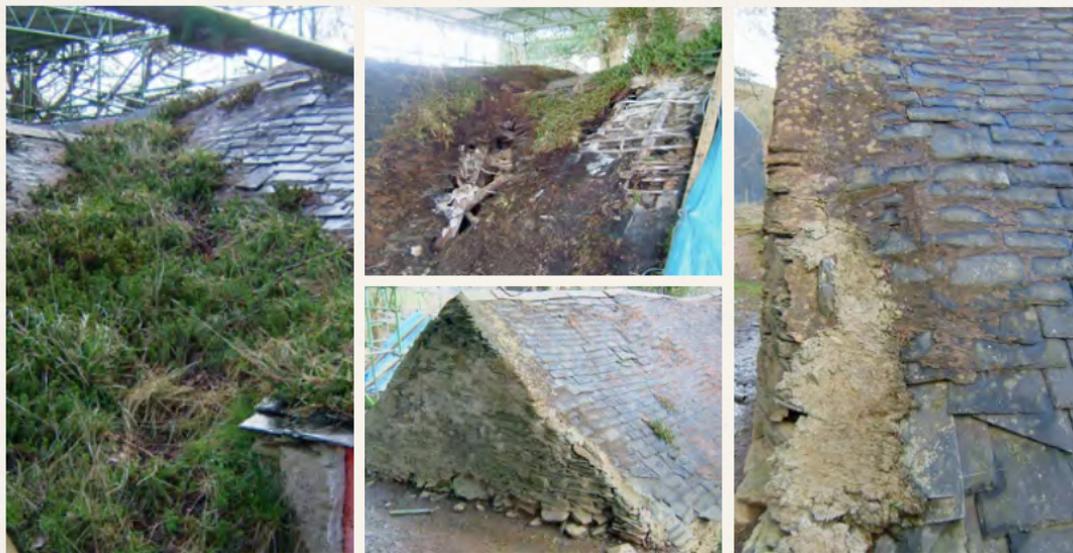
The roof has suffered from a series of ineffective repairs and a long period of neglect

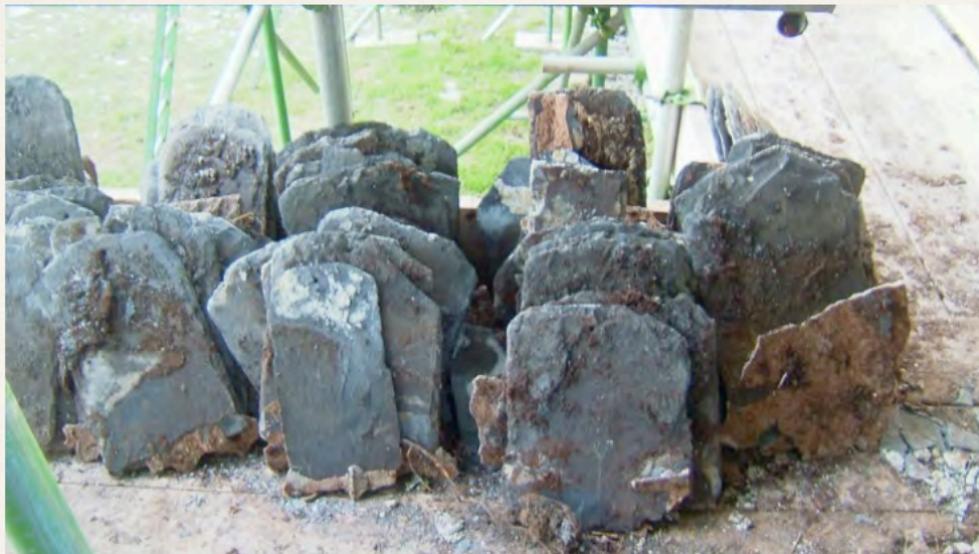
The slates are random sized from an unidentified local quarry and are in good condition. They range in length from 13 to 9 1/2 inches. There are 32 courses on both the main slopes.

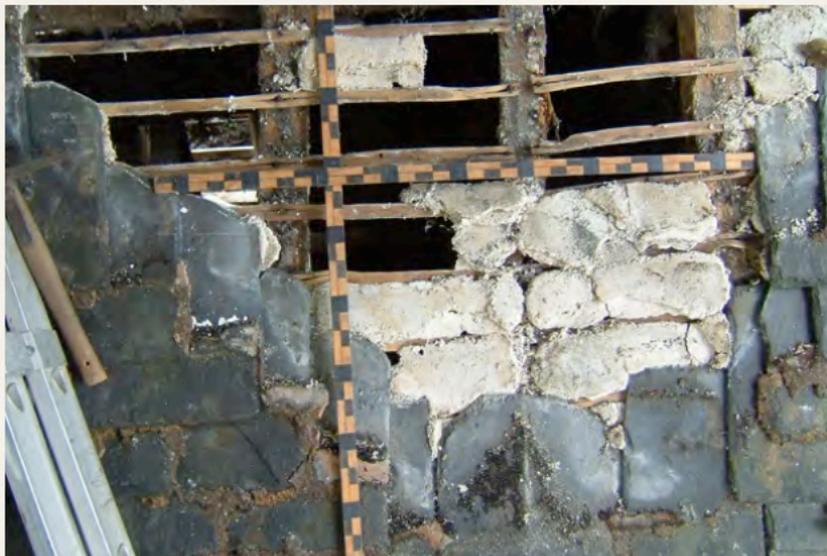
The slates are laid in diminishing courses hung on wooden pegs from riven laths fixed with iron nails and fully torched in lime mortar.
Much of the roof has been grouted at the slates' tails and the perpendicular joints and slurried over large areas

Head fixing with pegs should be retained for authenticity but it is possible to use nail fixing in battens if complete authenticity is not required. However, peg fixing relies on torching or head bedding (pin pointing) to improve the resistance to wind uplift. If torching is not possible then head bedding should be adopted.

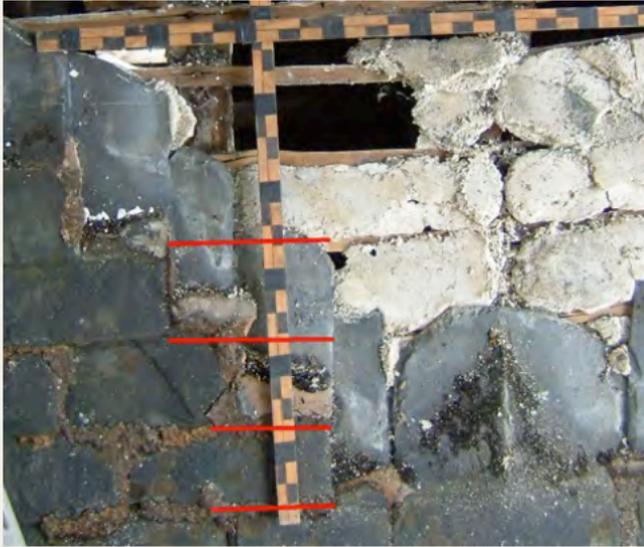
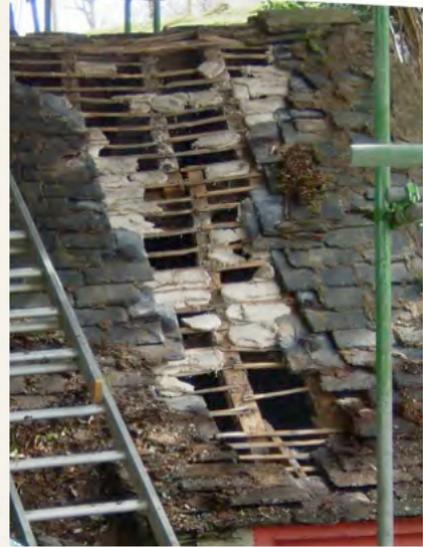
The slating is gauged at one third lap. This is a simple system where the laths are spaced at one third of the slate length. The head lap is therefore also one third of the length which is generous and automatically reduces for as the slates reduce in length. The system is only applicable to small slates: large slates would have wastefully large head laps.

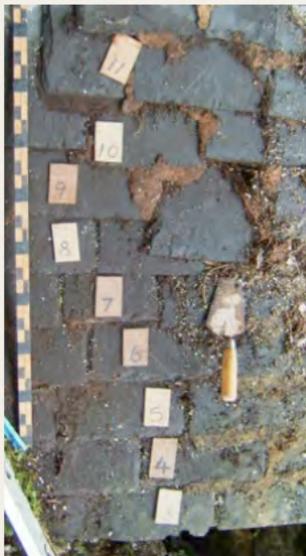
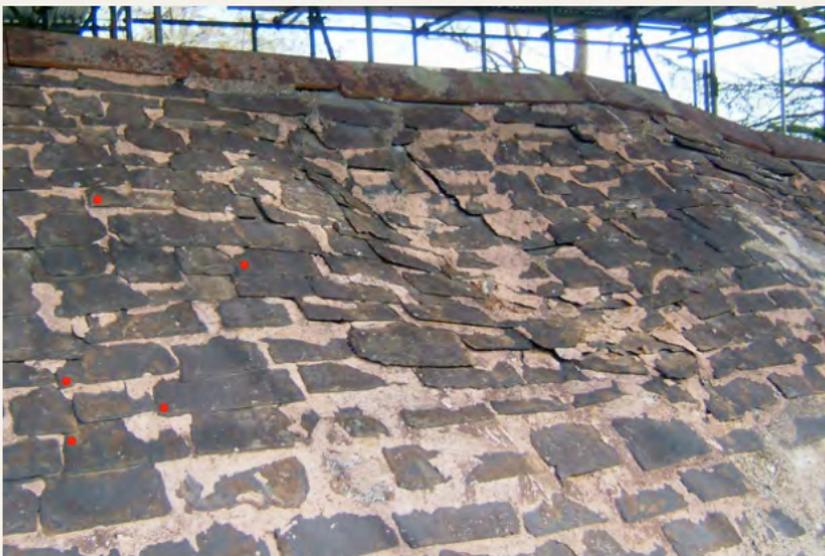
The slating has generally been laid with adequate side laps but there are examples where they are too small and would have resulted in leaks.

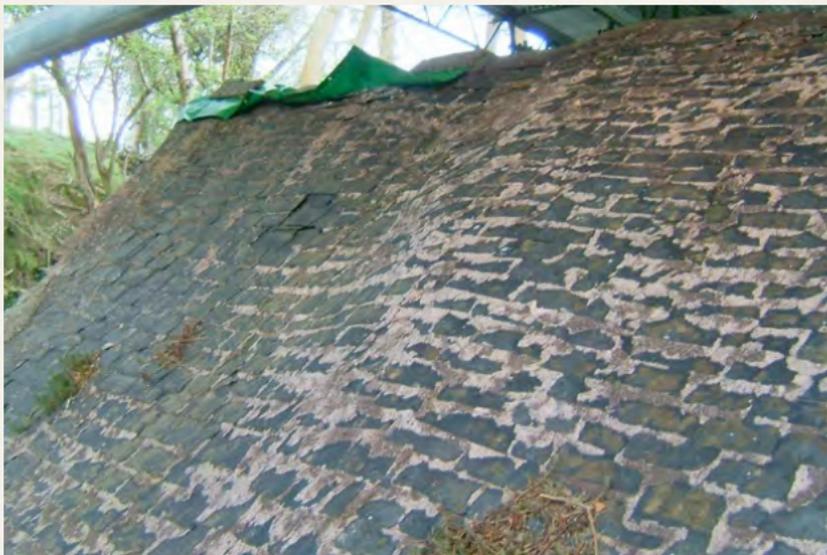
Undersized and rotted roof timbers and laths have allowed the slating to fold-in between the rafters producing an undulating surface. The crests of some of the undulations are so severe they will need to be eased to allow the slates to sit tightly together when the roof is relaid.

Where the roof slopes are heavily convex (in effect forming a hip) as in slope B1 it will be impossible to slate across the 'hip' without risking leaks. There are two options to overcome this. Firstly, a definite mitred hip could be formed and weathered with lead soakers. This would change the character of the roof. Alternatively, the sharpness of the 'hip' could be reduced by packing out over the rafters and narrower slates selected for the area. Narrower slates will lie more closely to the curve without the tails or lower corners kicking. Even if the latter option is adopted it may be necessary to soaker this area.

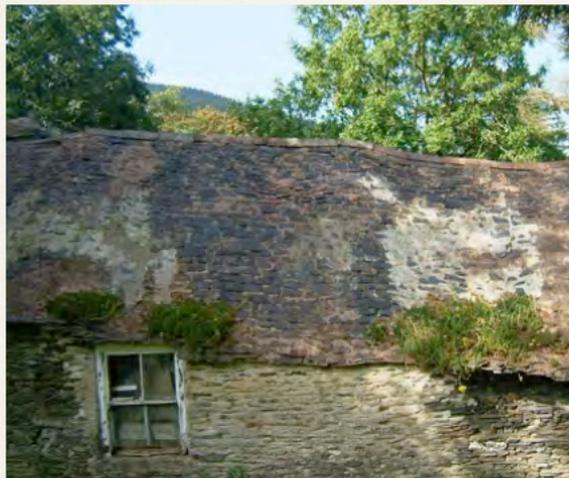
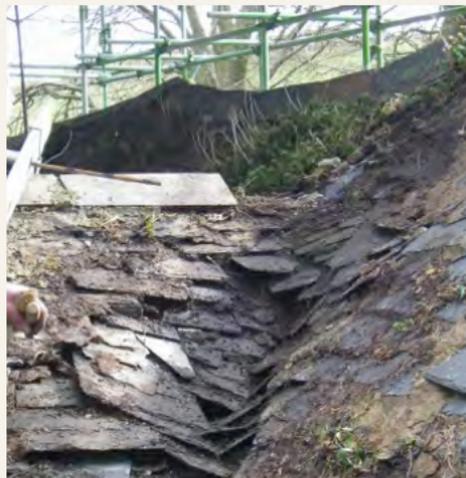
The eaves are formed with a conventional two layers of slate. The ridges are clay tile bedded and pointed. The chimney abutments are protected with crow steps and mortar flaunchings but without soakers or flashings

The crow step weathering of the chimney although traditional is not effective in preventing water penetration at the slate abutments. Lead soakers, one per course, with mortar flaunching is the most commonly adopted alternative.

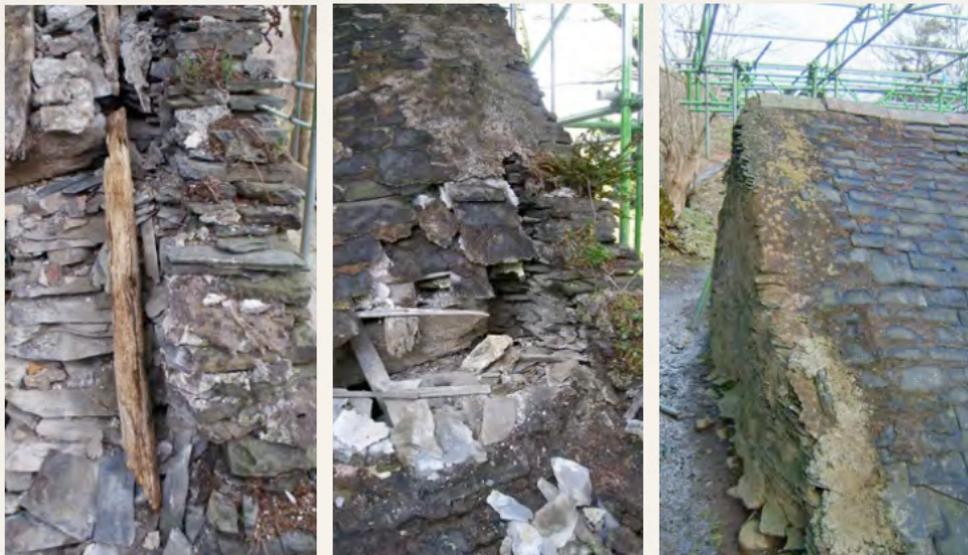
The inner leaf of the gable walls are set below the outer leaf. The slating butts up to the outer leaf without any form of weathering. This is thought to be a remnant of a former thatch roof. The junction of the slates and the outer leaf inevitably leak and crude attempts have been made to remedy this by coating with cement mortar. Also inevitably the rafters, laths and purlin ends have rotted.

A level of importance cannot be attributed to the peculiar butting of the slating against the outer leaf of the verges of slopes B1, B2 and C without further research into why it exists. As things stand it can only be regarded as a defective detail.

The verge abutments are simply defective and need to be redesigned. This may involve carrying the slating over the outer leaf or introducing a stepped damp course into the gable.

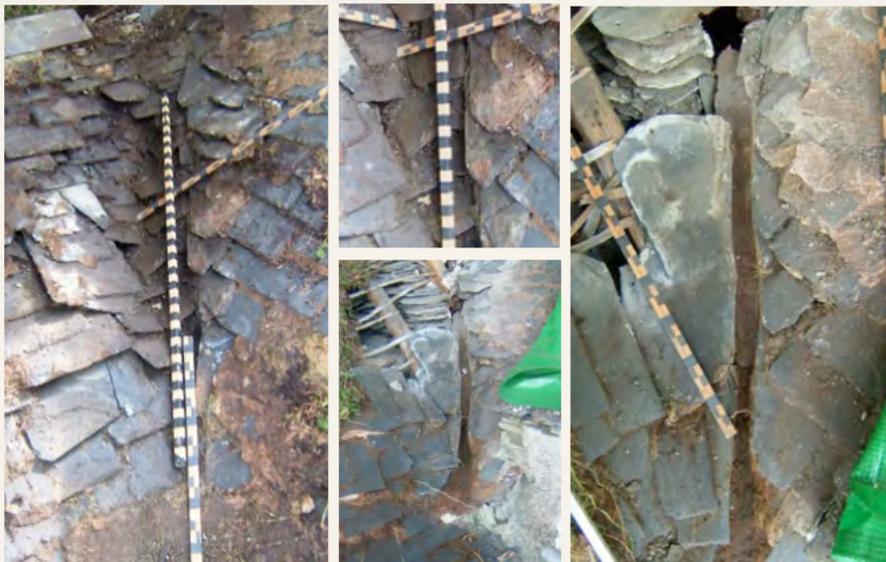
The valleys are complex and have been constructed in two phases. The south valley shown here is a single cut in the upper two thirds. The lower section associated with the lower pitch roof inserted over the later rear door is open and lined with metal which has been made from what appear to be biscuit tins.

Technically the single and double cut valleys can be effective and water-tight if carefully constructed but for complete security against leaks lead soakers could be included in each course. The existing open valley is undersized by modern standards and relied on the mortar bedding to prevent lateral leaks. The minimum width normally adopted for these valleys with un-bedded slating is 4 inch with the lead extending further under the slating than the existing and the inclusion of a tilt to support the slates.

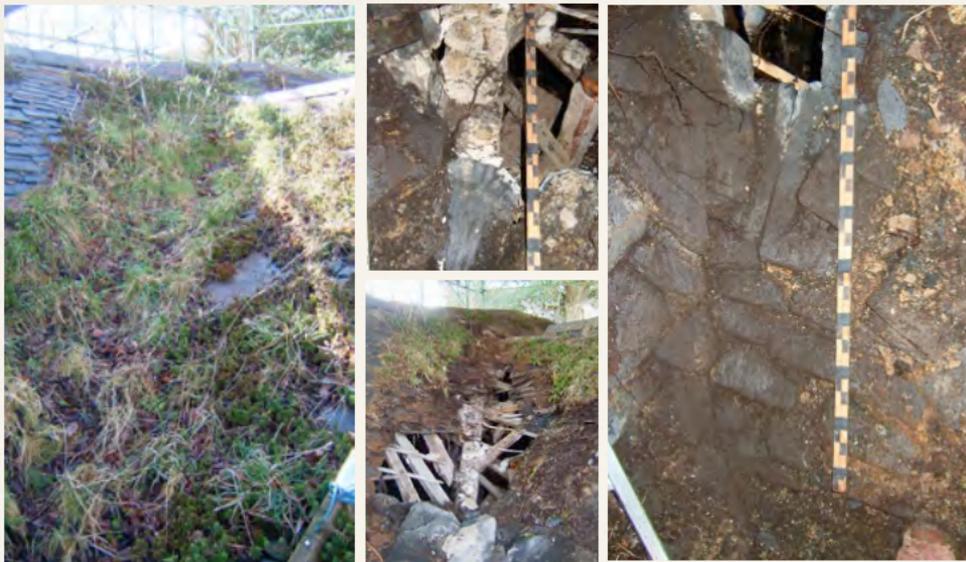
The north valley is swept in the upper third but single cut over the lower section. In both valleys the slates are fully bedded in lime mortar
