PENMAEN COTTAGE ROOF

Preliminary Appraisal

November 16 2012

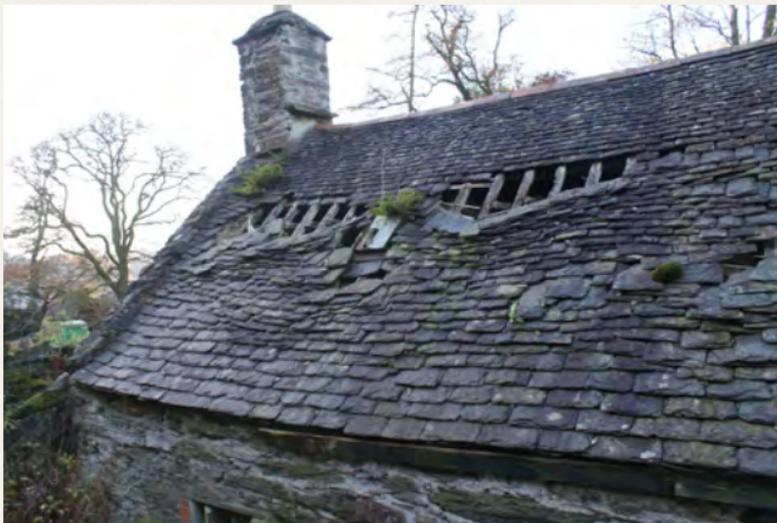
Slates And Slating

The slates are random sized and from a local quarry.

They are in very good condition.

They are laid in diminishing courses peg hung from riven laths at what seems to be one third lap.

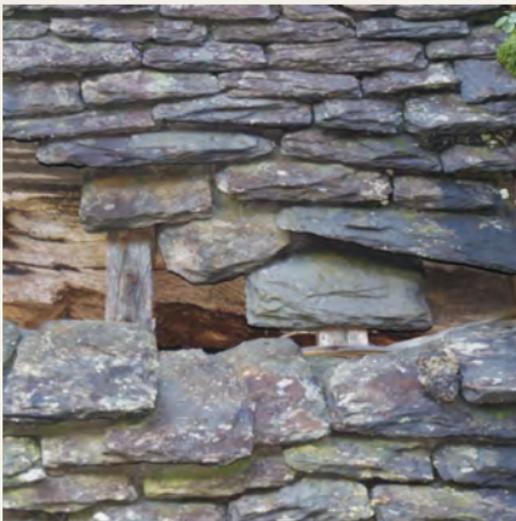
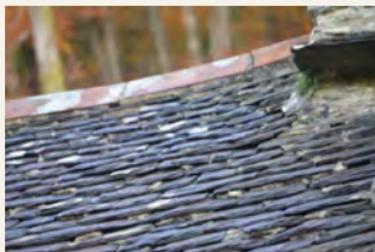
Mortar

On the rear slope there is no evidence of mortar bedding at the slates' tails or heads on the roof or on fallen slates.

On the front slope there is some tail bedding mortar visible

Torching is not apparent.

There is a lath and plaster ceiling which follows the line of the rafters and collars.

The wall head is packed with lime mortar up to the underside of the slates.

The room is open to the underside of the slating which is torched forming a ceiling.

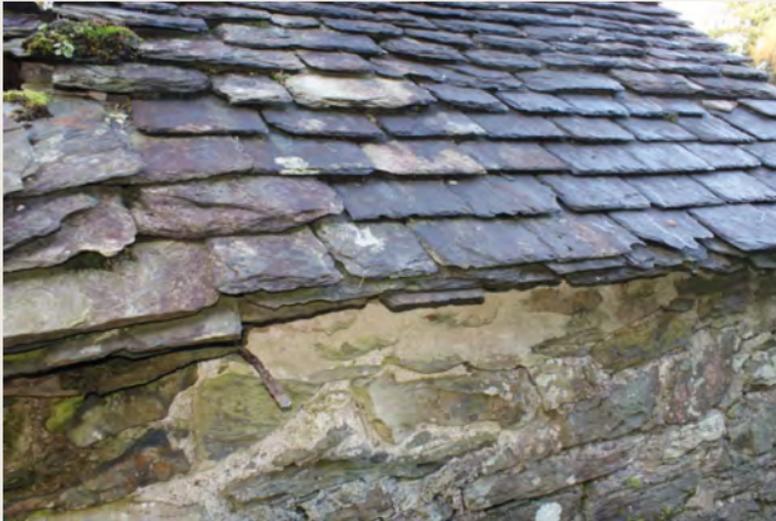
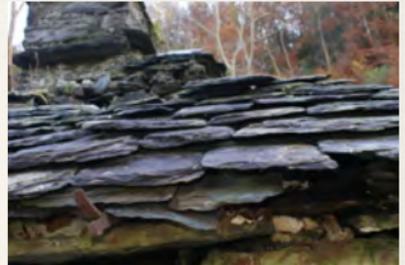
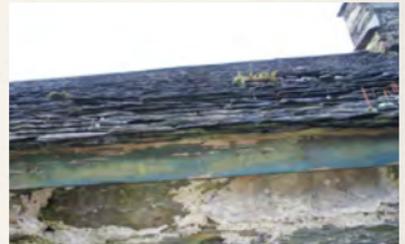
Eaves

There are three courses of slates at the eaves. This seems to be a traditional feature of Welsh slating its purpose being to provide a tilt to ensure the slates lay tightly against each other up the roof slope. In other traditions the tilt is provided by using a tilting fillet or by setting up a fascia board. The method of providing a tilt is influenced by the position of the rafter foot in relation to the outer face of the wall and in this tradition may be evidence that the roof was originally constructed for a different roof covering such as thatch.

Rainwater gutters are missing but were formerly fixed to fascia boards or supported on brackets spiked into the wall. The slate overhang is small in places indicating the gutters were not contemporary with the slating. If they are to be reinstated the slate overhang will need to be adjusted.

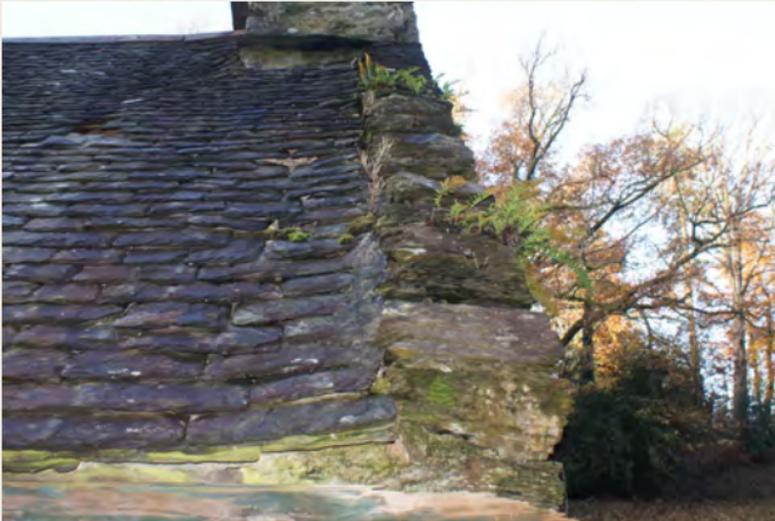
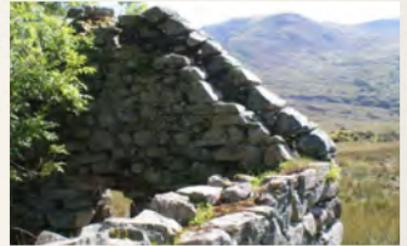
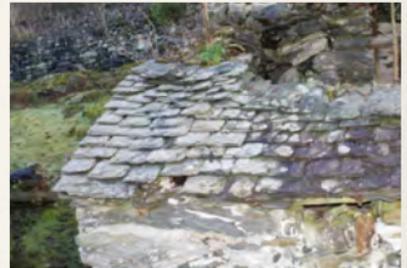
Verges

The verge slating is butted up to a raised outer leaf of the gable wall. This is a weak detail and prone to leaks even when metal soakers are included which is unlikely here. The detail is thought to be a legacy of thatching. It is anticipated that the inner leaf of the wall will have been constructed to follow the roof line as shown in the upper right image from Cwm Nantcol.

The verge slating is carried over the gable wall

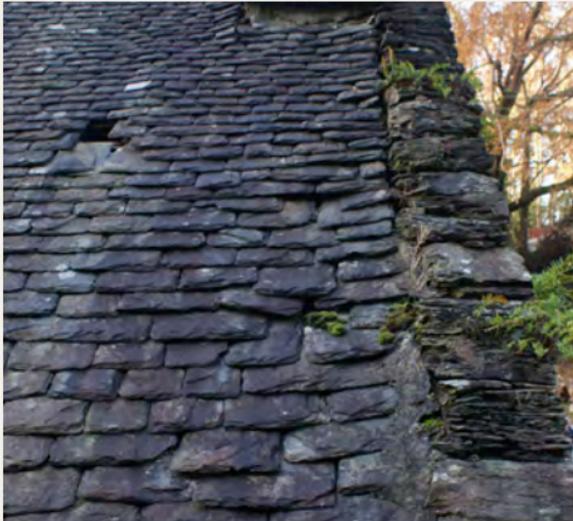
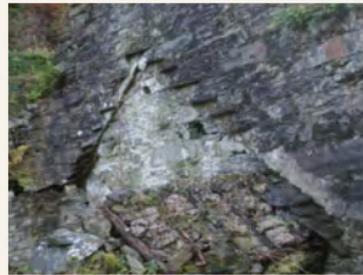
Abutments

At each abutment the slating is turned up to direct water away from the junction.
Chimney and wall abutments are protected with crow steps and mortar flaunches.

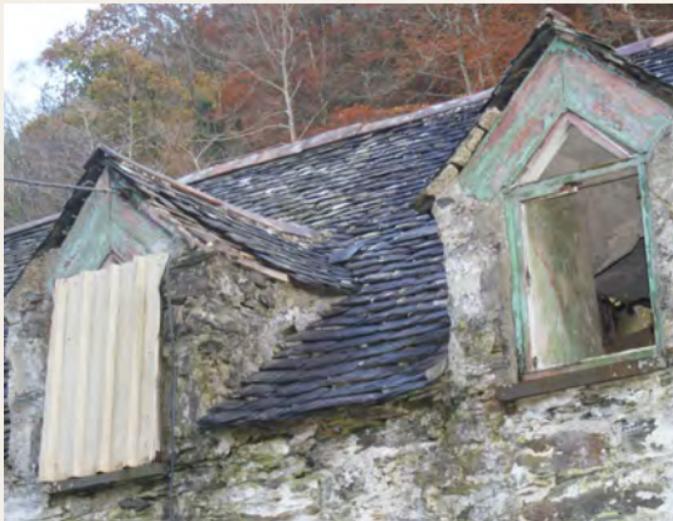
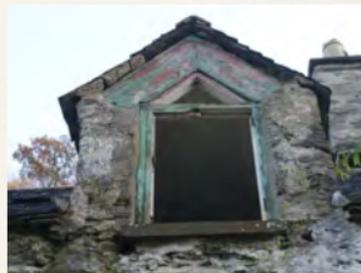
Dormer Windows

The dormers are gabled with un-socketed clay tile ridges and barge boards set back from the wall face.

The ridges run directly into the main slating and may be weathered with metal soakers.

The valleys appear to be single (half) cut where the slates are swept from the dormer slope underneath the main slating. The possible line of the cut is shown top right.

The underside of the verge slates are mortared but there are no under-cloaks. These may have fallen off.

On the right hand dormer there are metal soakers at the foot of the abutment slating but not along the abutment.

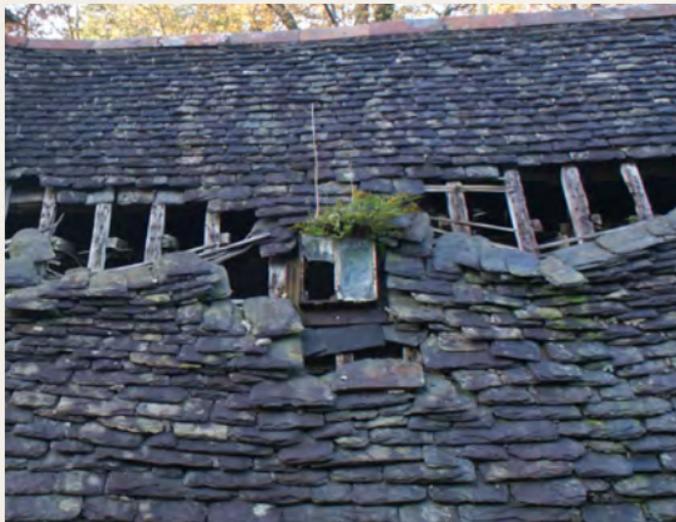
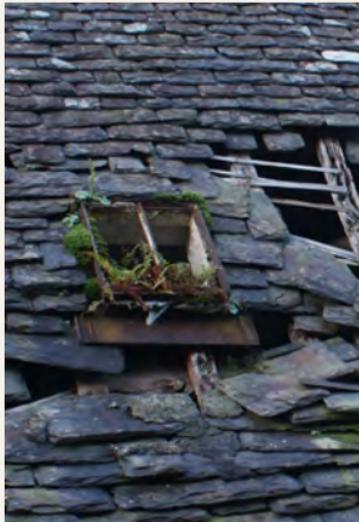
Roof Lights

There are two cast iron roofs lights in the rear slope. They appear to be in good condition

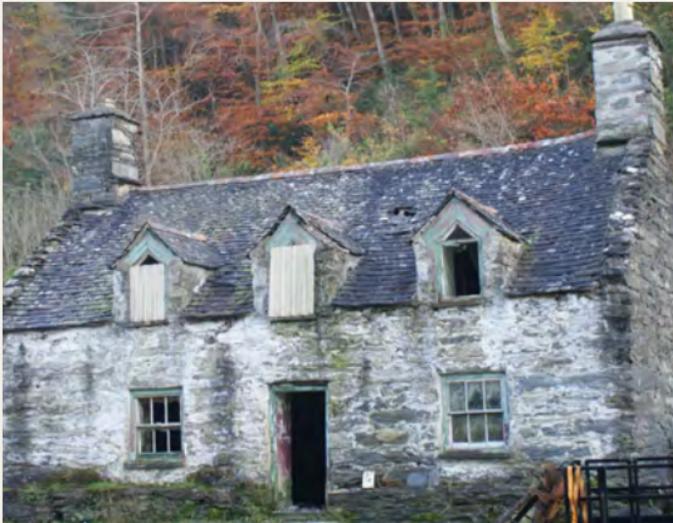
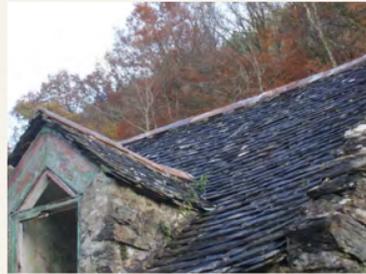
Ridge

The ridges are un-socketed red clay tiles.

There is no vertical deflection at the ridge line nor, as far as can be seen, any lateral displacement of the ridge or eaves bowing. These indicate the roof structure is stable.

On the lower roof the front wall is unstable at the doorway,

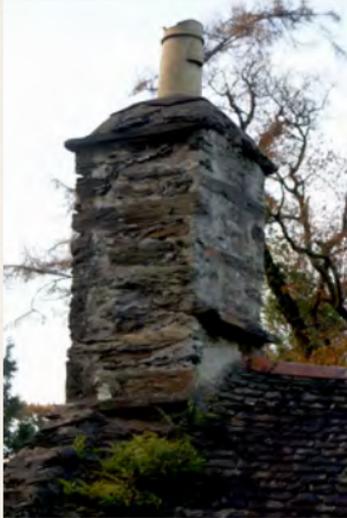
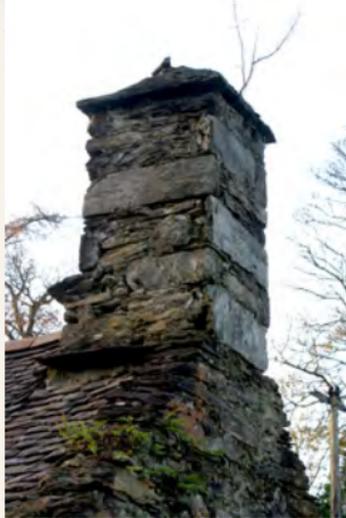
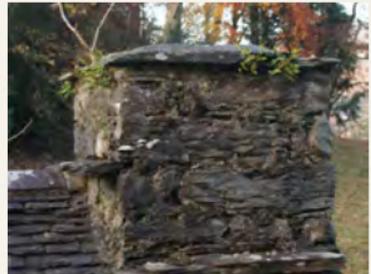
Chimneys

The tall chimneys with clay pots and tall haunching are typical of the local style. Much of the flaggy stonework is set upright and cut to form the full width of the wall face. Crow steps are set into the masonry to weather the slate abutments.

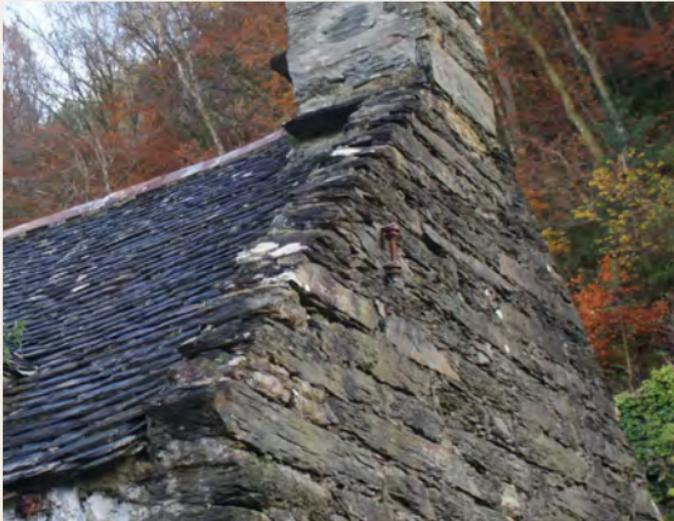
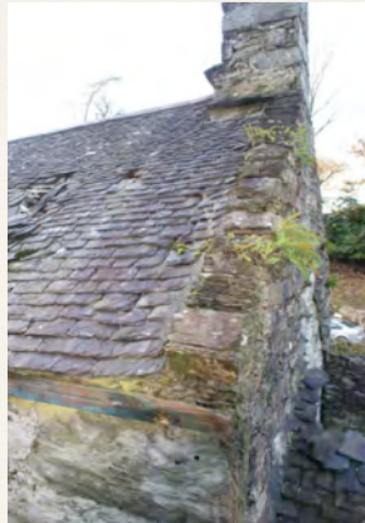
Gables

The gables are formed with long slabs tying the roof line back to the wall.
On the upper roof the gables finish above the slating (see abutments).
